Case Study

Exterior Renovation

Bronx, New York

3800 Waldo Avenue: A Fresh New Look for a Bronx Building's Exterior

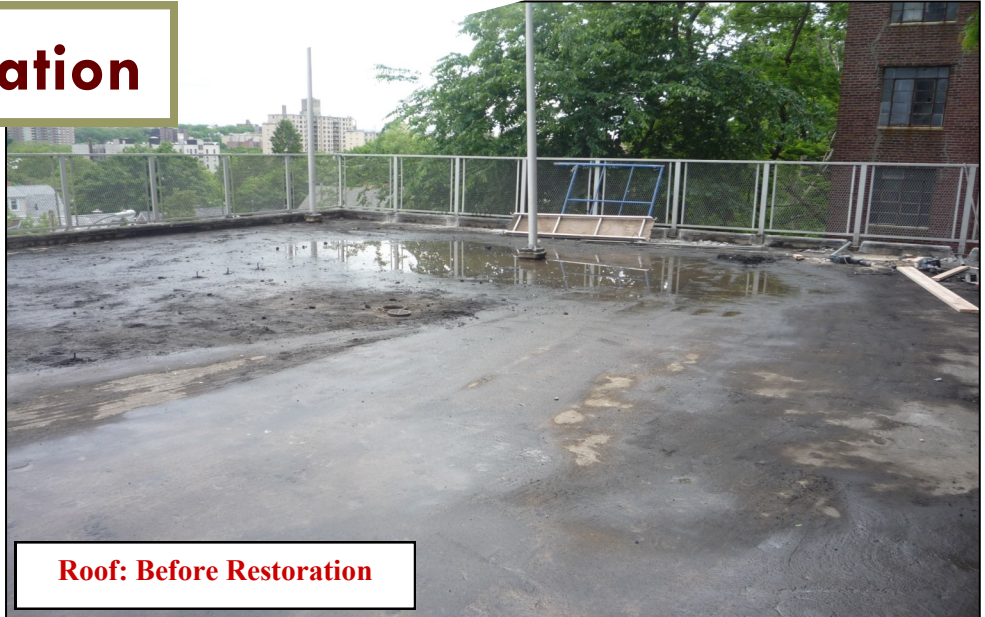
Roof: Before Restoration

and replacement of the roof deck above the upper section of the parking lot, adjacent to the building. The existing asphalt atop the roof deck, approximately 6 to 8 inches thick, was extremely porous and allowed significant amounts of moisture to penetrate the roof, through the concrete deck and down to the parking spaces below. Not only did the current conditions prove to be unsafe, but they were also staining the walls and damaging cars below.

After removing all of the asphalt down to the bare concrete deck, the deck was then patched from the topside and underside. The railing base posts were completely repaired and all of the concrete curbs around the perimeter of the roof deck were repaired. The existing drains, placed at the building line, were plugged and abandoned and three new drains were installed in the center of the roof deck. The new draining system specified by Merritt allowed for a slightly sloped roofing surface towards the center of the roof and also prevented water from being pitched towards the building.

Once all of the roofing repairs were conducted, a new 20-year roofing membrane was installed. The new roofing system was fully water tested in order to ensure that it was installed properly and was not allowing water to penetrate the membrane. Finally, once the roofing system was complete, concrete pavers

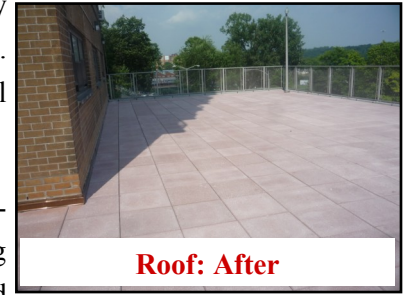
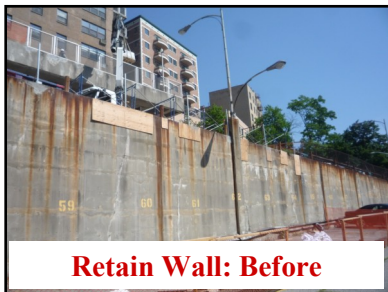
Phases 2 through 4. The following phases of work were focused on repairing the unsafe conditions that were present at the retaining walls along both levels of the parking lot. These walls were deemed unsafe in the 6th Cycle Local Law 11/98 Report and needed to be repaired within a designated time frame. The spalled and cracked areas were demolished and repaired with Euclid products. Certain cracks were also repaired with epoxy injection and all of the expansion joints were replaced. The rust staining that was present was also removed. Once these repairs had a chance to fully cure and the walls were fully cleaned, they were coated with two coats of elastomeric coating.

All of the existing chain link fencing on the property was in disrepair and needed to be replaced. The fence posts were all chopped out of the existing concrete. Each new post needed to be embedded into the retaining wall at a minimum depth of 18 inches. The new chain link fence was then rolled into place. Varying fence and post heights were required throughout the property based on the existing conditions. Because of the landscaping at the property, maintenance will need to be conducted prevent shrubbery from growing up against the fence, which previously caused fence damage at the property.

All of the existing guard rails located throughout the parking lot were also replaced. They were replaced with new galvanized sections of guard rail that were bolted to existing posts embedded into the retaining walls. These guard rails were only located along the retaining wall which separates the upper parking deck from the lower parking deck. The remaining guard rails were replaced with new rubber bumpers. These new rubber bumpers have been constructed of old recycled tires which not only save the Owner on overall cost, but also provided an environmentally friendly solution.
